# ***DOGWOOD*** *home inspection*

## Home Inspection Report

**1234 N Home St.**

Inspected on Sun, Nov 17 2013 at 12:25 PM

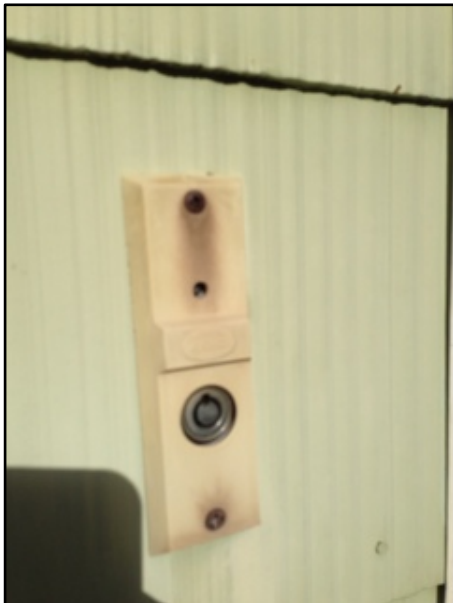
Figure 1-1

An alarm system is installed. it must be activated in order to work.

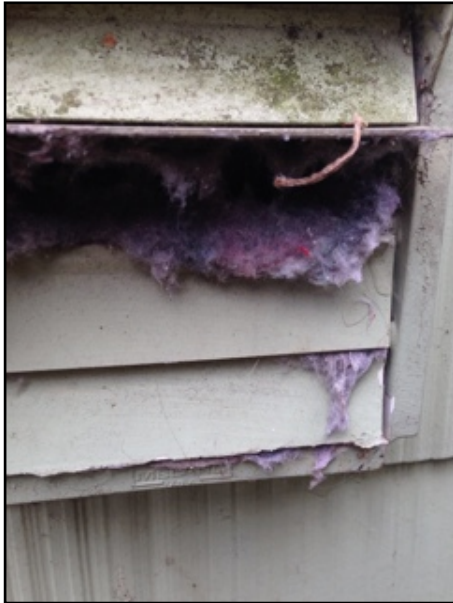
Figure 2-1

The dryer vent needs to be cleaned in order to function properly.

1) The dryer vent needs to be cleaned in order to function properly.

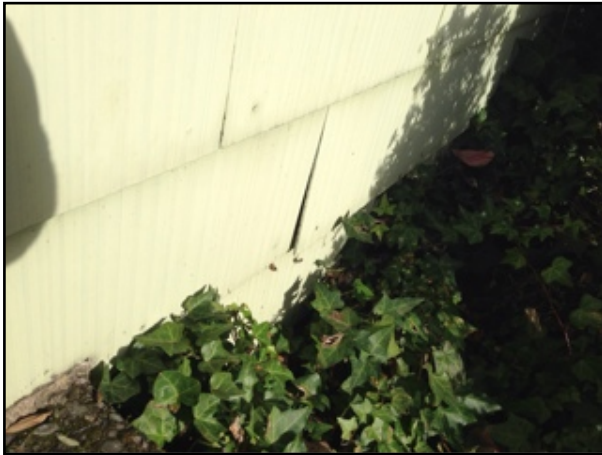
Figure 3-1

**Comment 3:**  
Ivy is growing against the structure.

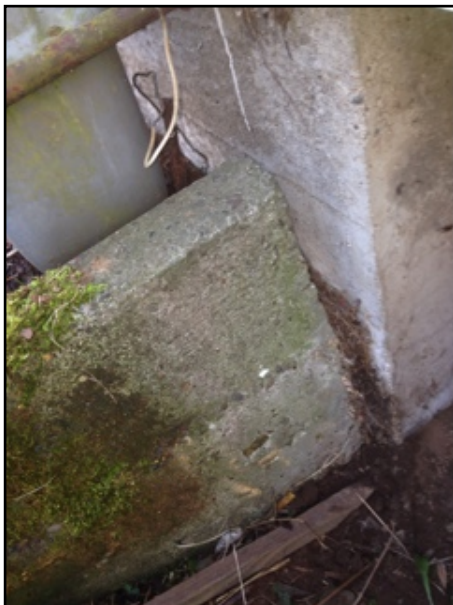
Figure 4-1

**Comment 4:**  
The concrete at the CRAWLSPACE access has clearly settled away from the building indicating an excess of moisture leading to settling. It is possible that footer drains are contributing to this.

2) The concrete at the CRAWLSPACE access has clearly settled away from the building indicating an excess of moisture leading to settling. It is possible that footer drains are contributing to this.

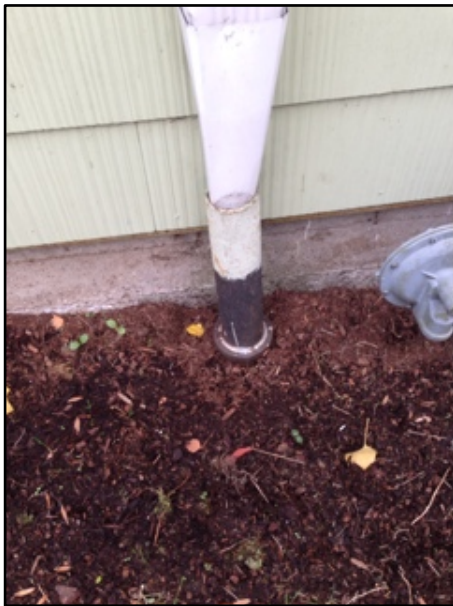
Figure 5-1

Storm drains are still attached to city sewer waste system.

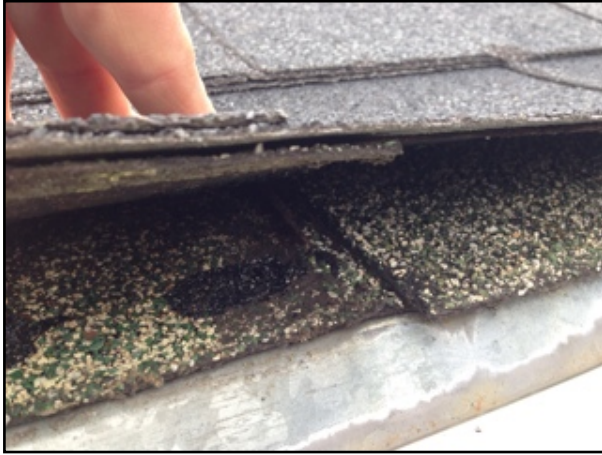
Figure 6-1

There presently two layers of roofing installed. The next roofing install will require a complete tear-off.

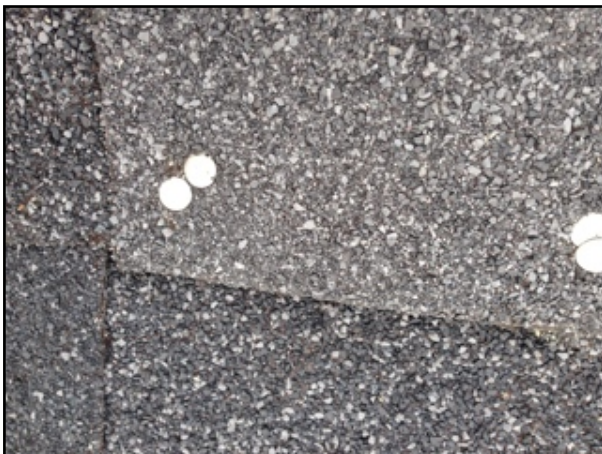
Figure 7-1

There are a few face nailed roofing nails at the peak of the structure. These nails should have Rubber gaskets. Silicone caulking or roofing tar should be applied to these nails.

3) There are a few face nailed roofing nails at the peak of the structure. These nails should have Rubber gaskets. Silicone caulking or roofing tar should be applied to these nails.

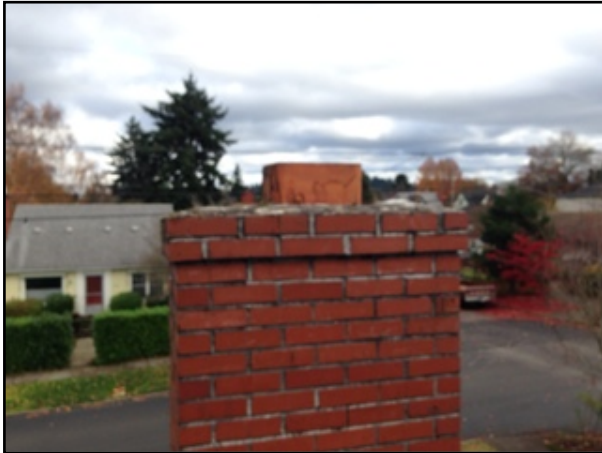
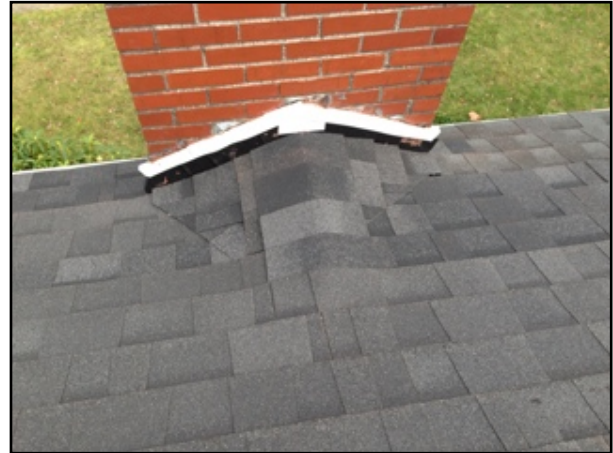
The masonry chimney appears to be lined. It also has a cricket installed. A spark arrestor and Chimneycap are recommended for the chimney to prevent moisture from entering.

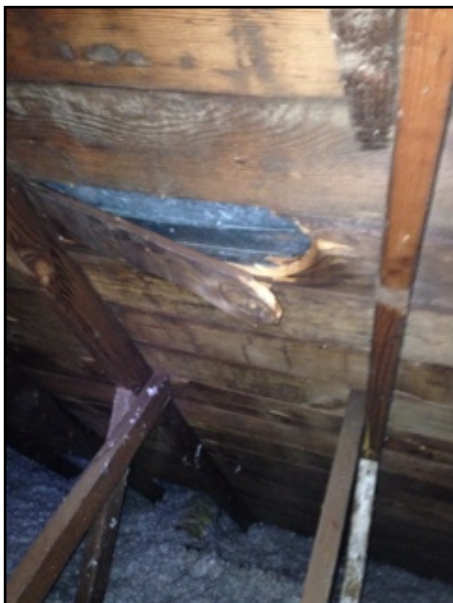
Figure 9-1

A former roof leak that appears to have led to significant rot, has been properly repaired. It appears that the rotten wood has been removed and replaced.

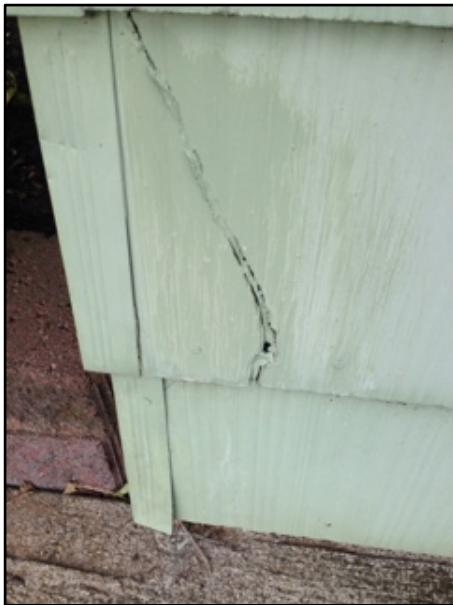
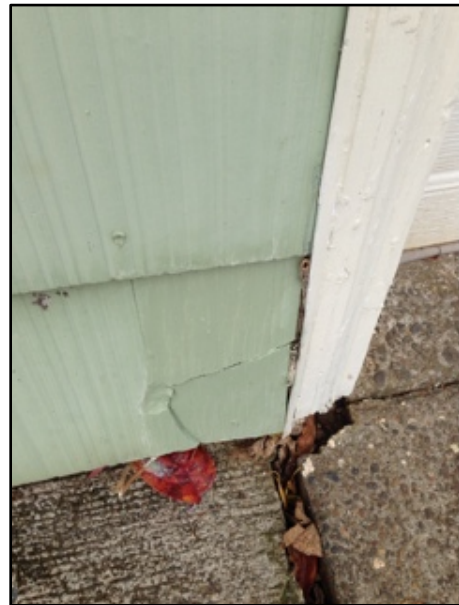
Several asbestos tiles are cracked. These should be maintained to prevent further cracking.

4) Several asbestos tiles are cracked. These should be maintained to prevent further cracking.

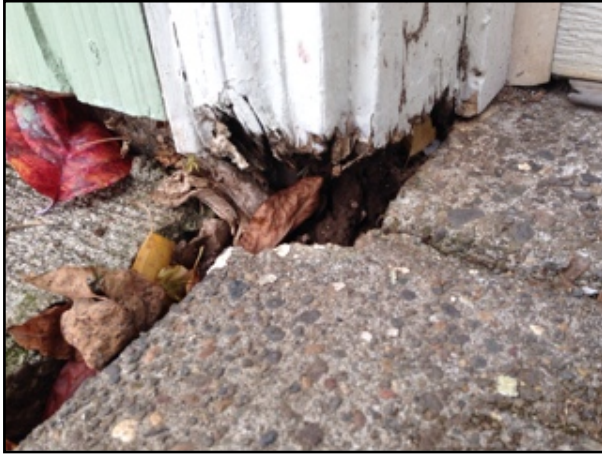
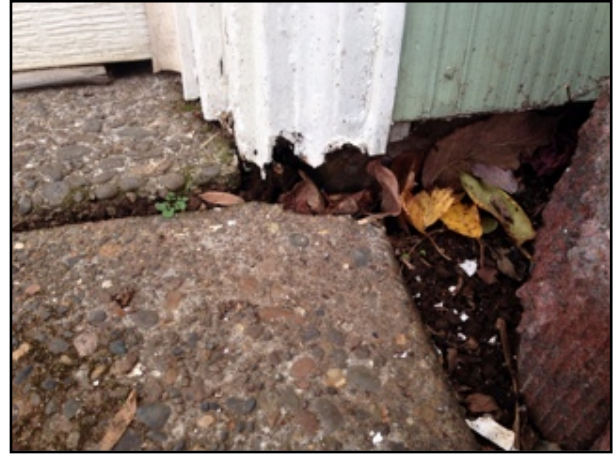
The trim at the garage door is showing signs of rot at its base. This is due to water collection at the driveway.

5) The trim at the garage door is showing signs of rot at its base. This is due to water collection at the driveway.

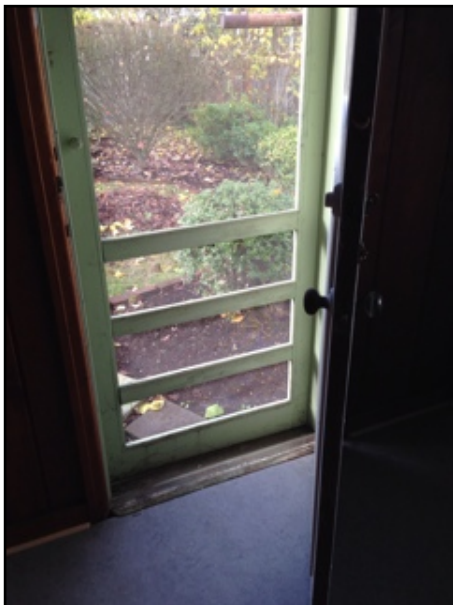
Figure 12-1

The back door does not open or close easily and will require some repair to function properly.

6) The back door does not open or close easily and will require some repair to function properly.

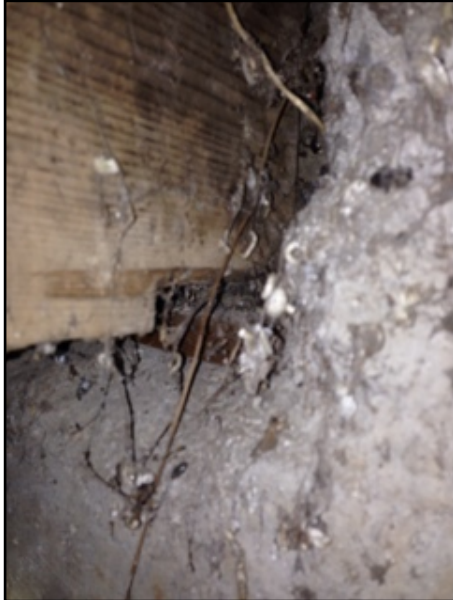
Figure 13-1

The north foundation walls appears to have settled by at least 1 1/2". This has resulted in the beam not resting on the foundation wall. This will result in further settling and should be repaired immediately. This should be repaired with the use of shims.

7) The north foundation walls appears to have settled by at least 1 1/2". This has resulted in the beam not resting on the foundation wall. This will result in further settling and should be repaired immediately. This should be repaired with the use of shims.

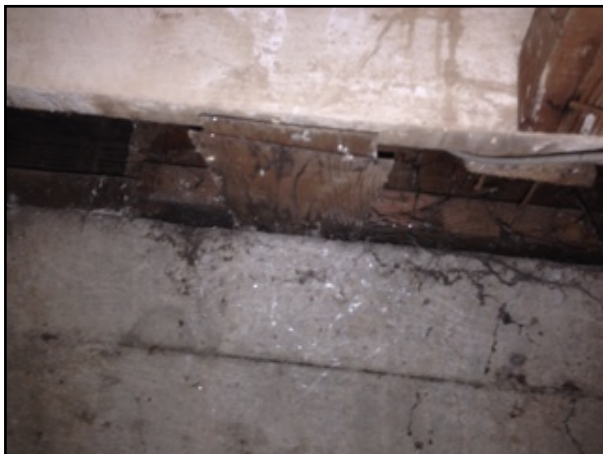
Figure 14-1

Some shifting in the sill plate has taken place and shims were applied to remedy this issue. In addition, foundation bolts are not present.

8) Some shifting in the sill plate has taken place and shims were applied to remedy this issue. In addition, foundation bolts are not present.

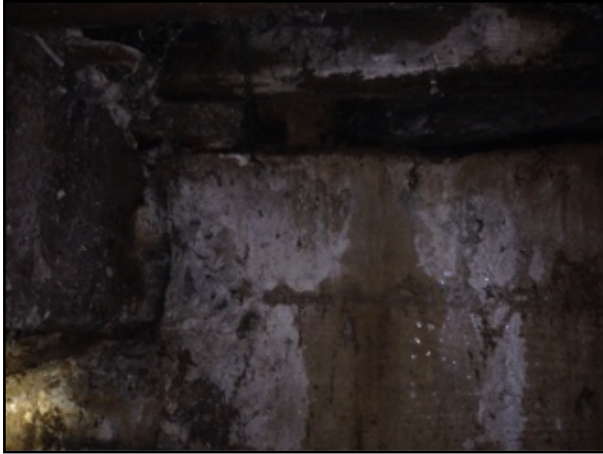
Figure 15-1

There is an 8 foot section of sill plate and related framing members that has rotted. This appears to be due to a water intrusion at the front of the structure. This failure has resulted in the settling of the front wall which has resulted in cracking at the kitchen wall. This failure needs to be replaced immediately to prevent any further settling.

9) There is an 8 foot section of sill plate and related framing members that has rotted. This appears to be due to a water intrusion at the front of the structure. This failure has resulted in the settling of the front wall which has resulted in cracking at the kitchen wall. This failure needs to be replaced immediately to prevent any further settling.

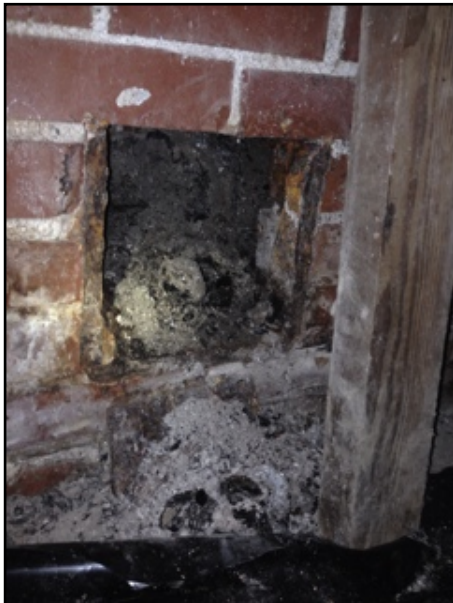
Figure 16-1

The ash clean out at the CRAWLSPACE is missing its cover. If the fireplace is to be converted back to a wood burning unit, this will need to be repaired.

10) The ash clean out at the CRAWLSPACE is missing its cover. If the fireplace is to be converted back to a wood burning unit, this will need to be repaired.

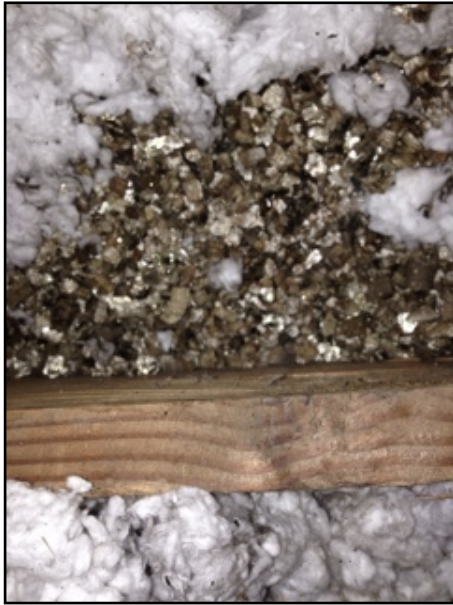
Figure 17-1

Comment 17:  
Vermiculite insulation installed.

11) Vermiculite insulation installed.

Comment 18:  
Check out this link on vermiculite insulation.  
<http://www2.epa.gov/asbestos/protect-your-family-asbestos-contaminated-vermiculite-insulation#insulation>

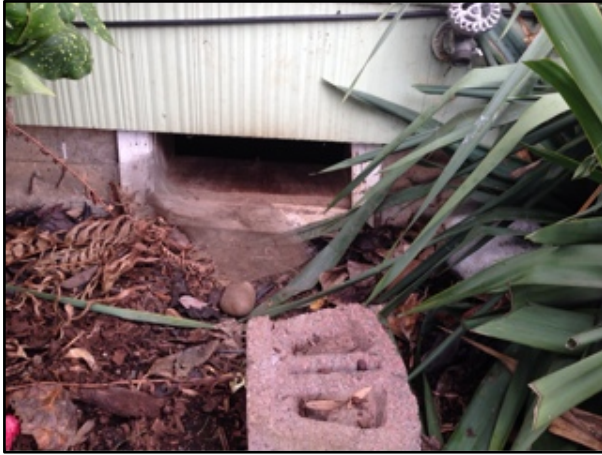
Figure 19-1

The screen at crawl space vent at the east side is loose and needs to be re-secured.

It is evident that animals have used this hole has access to the crawlspace.

12) The screen at crawl space vent at the east side is loose and needs to be re-secured.

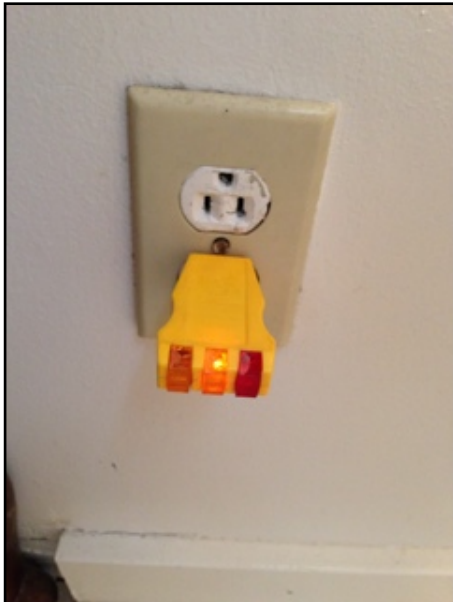
Figure 20-1

Some of the outlets in the house are improperly wired 3 prong outlets and should be switched with 2 prong outlets. This one is in the bathroom.

13) Some of the outlets in the house are improperly wired 3 prong outlets and should be switched with 2 prong outlets. This one is in the bathroom.

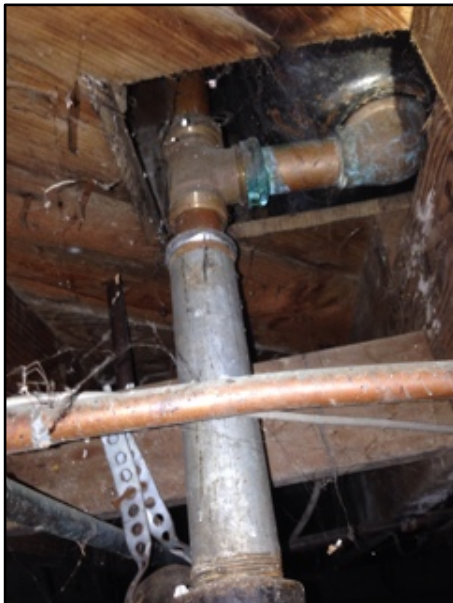
Figure 23-1

Comment 23:  
There is a leak in the waste line at the bathtub evident in the crawl space.

14) There is a leak in the waste line at the bathtub evident in the crawl space.

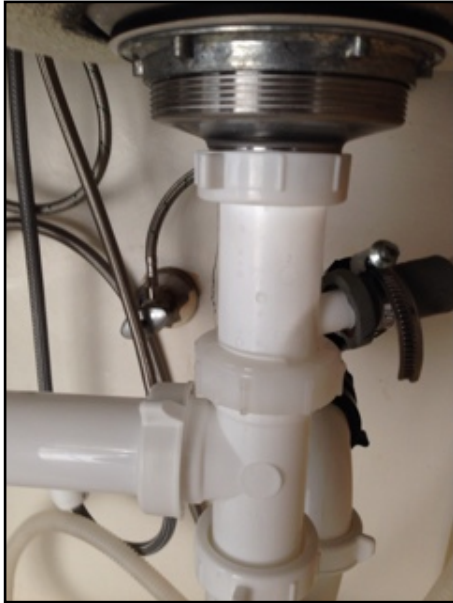
Figure 24-1

Multiple leaks under the kitchensink at the waste lines.

The kitchen waste line from the left side of the sink to the trap side isn't at the proper drop. 1/4" per foot is recommended. I believe this could be a problem for proper flow.

15) Multiple leaks under the kitchensink at the waste lines.

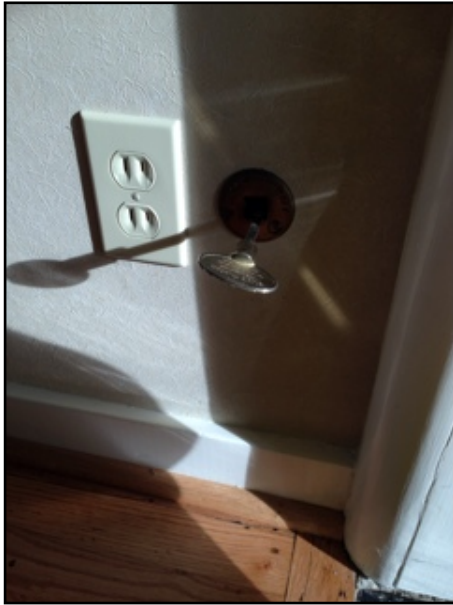
Figure 25-1

There is a gas fireplace system installed.

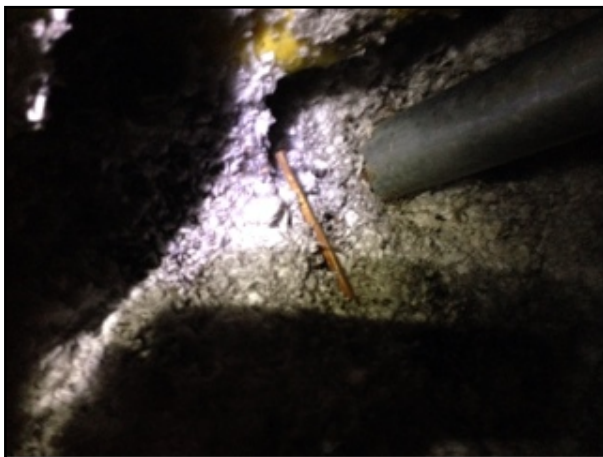
Figure 26-1

The furnace flue vent appears to be a single walled vent. It should be at least 6" from combustible material. In the attic and through the roofing, there does not appear to be proper clearance.

16) The furnace flue vent appears to be a single walled vent. It should be at least 6" from combustible material. In the attic and through the roofing, there does not appear to be proper clearance.

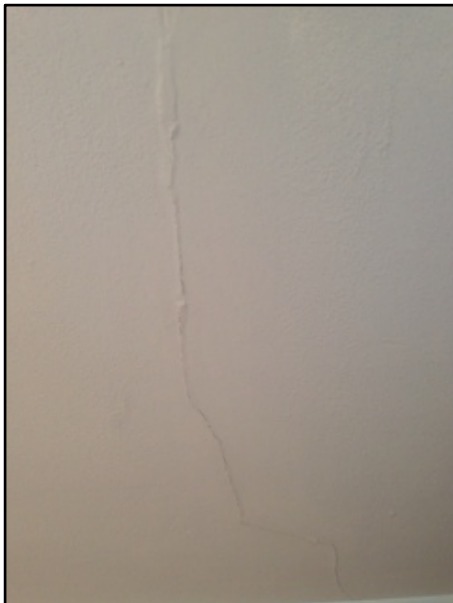
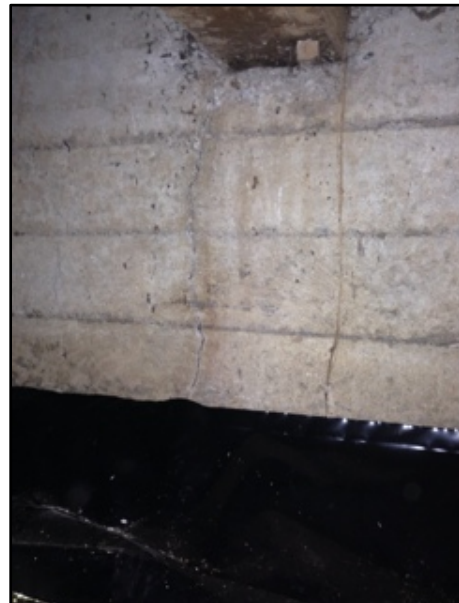
There is a crack below the window in the bedroom adjacent to the bathroom. This directly corresponds to a former roof leak that has been repaired evident in the attic.

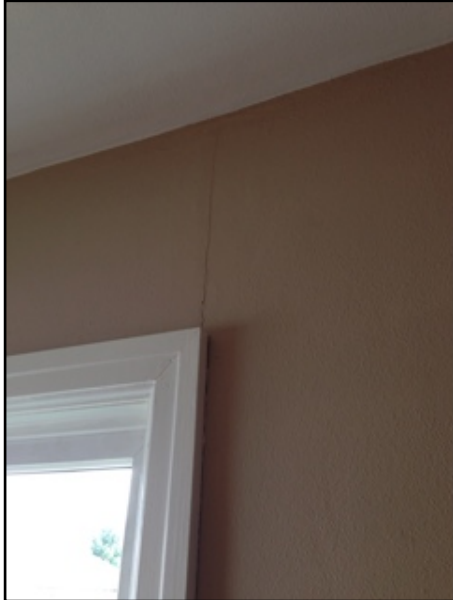
Figure 28-1

There is a crack in the wall in the back bedroom that corresponds to a foundation crack, coupled with the settling of the foundation wall.

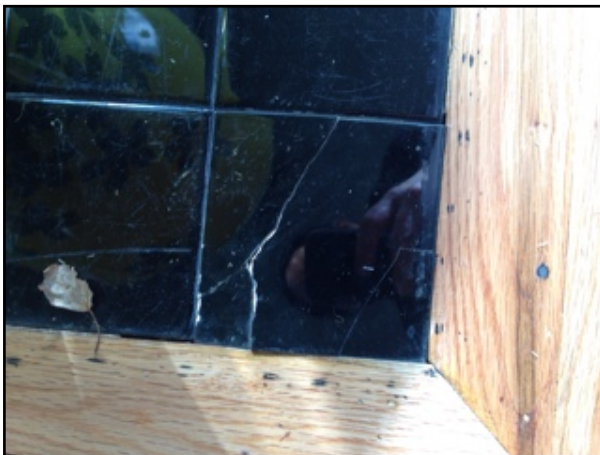
Figure 29-1

There is a cracked tile at the fireplace hearth.

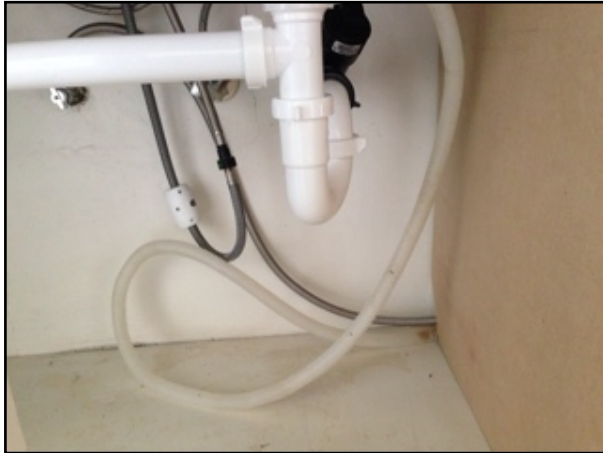
Figure 30-1

The dishwasher drain requires a loop at the top of the cabinet area higher than the sink drain trap. There was no high loop present at this inspection. The high loop should be installed to prevent backflow into the dishwasher.

17) The dishwasher drain requires a loop at the top of the cabinet area higher than the sink drain trap. There was no high loop present at this inspection. The high loop should be installed to prevent backflow into the dishwasher.

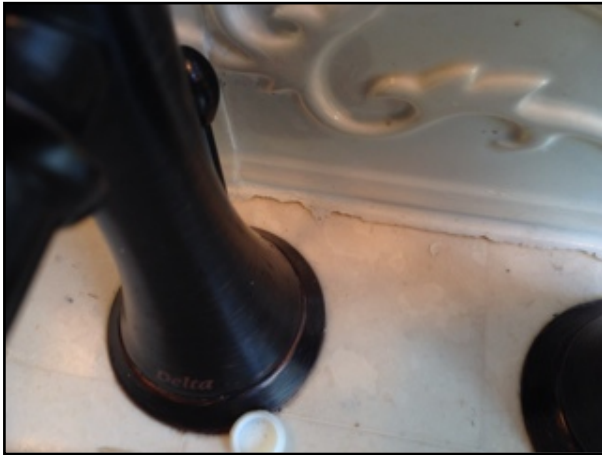
Figure 31-1

Caulking at the bathroom counter is showing signs of failing.

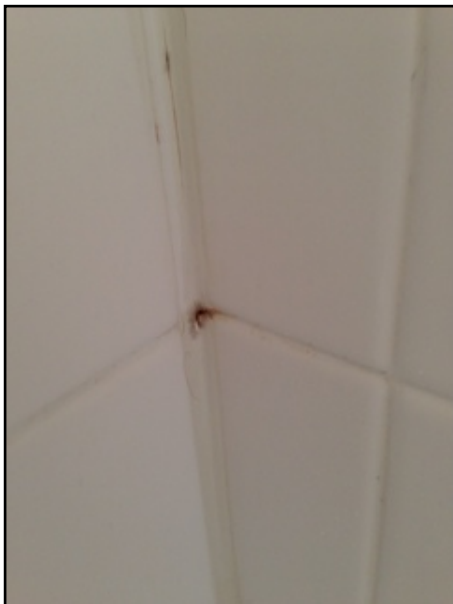
Figure 32-1

Some mildew is evident at the shower. The surround is made of plastic which requires caulking instead of grout which is more susceptible to mildew.

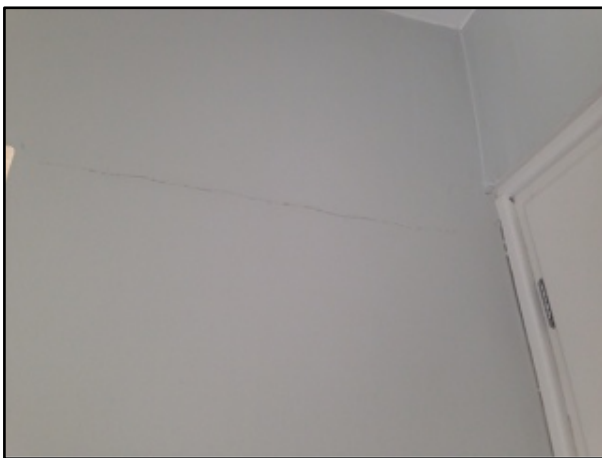
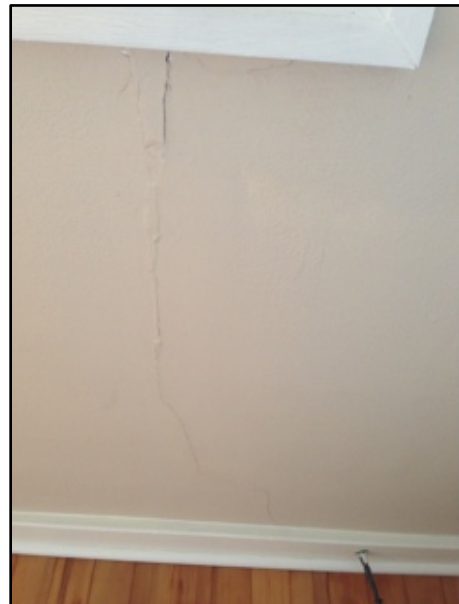
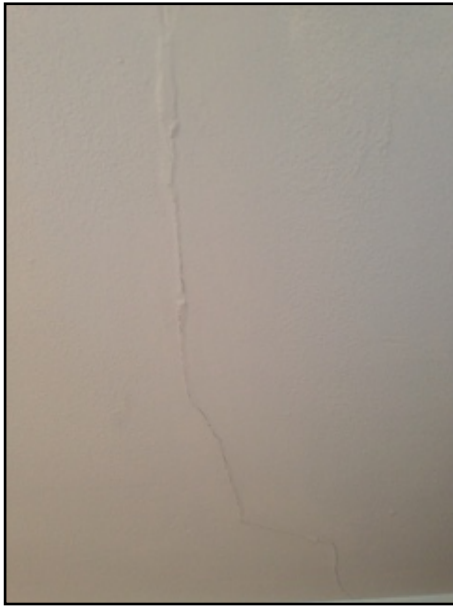
there are cracks in the wall that indicate some movement in the structure. I determined that there has been some movement in the foundation that has contributed to these cracks.

18) there are cracks in the wall that indicate some movement in the structure. I determined that there has been some movement in the foundation that has contributed to these cracks.
